MANAGING ACID SULFATE SOILS

In-Pit Tailings Storage – Overview

In-Pit Tailings Storage – A Case Study

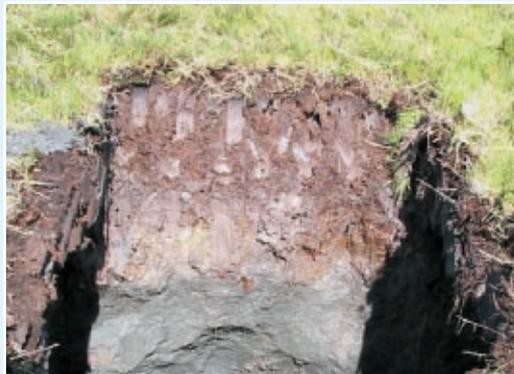
The accompanying photograph shows a test pit from a site investigation in a coastal area of Victoria. Actual acid sulfate soil (AASS) overlying PASS was immediately suspected during the excavation because of the rich iron red colour of the clay in open fissures in the zone above the grey clay.

Test pit from a site investigation.

Both AASS and PASS were subsequently verified by laboratory testing. It was found that the water table in the formerly swampy area had been lowered to the level of the red/grey clay interface. Permanent saturation is a defence against acid runoff.

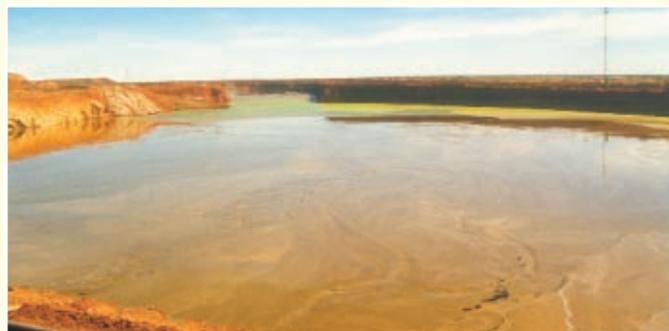
Bullakitchie Pit at Newmont's "The Granites" Gold Mine during filling. The wet surface is typical of in-pit tailings deposition and is an indication of underconsolidated tailings and considerable future surface settlement.

The aspect ratio of pits, combined with modern processing plant throughputs, almost invariably results in a rapid rate of rise of the tailings leading to an underconsolidated deposit. Such deposits undergo significant post-depositional settlements.

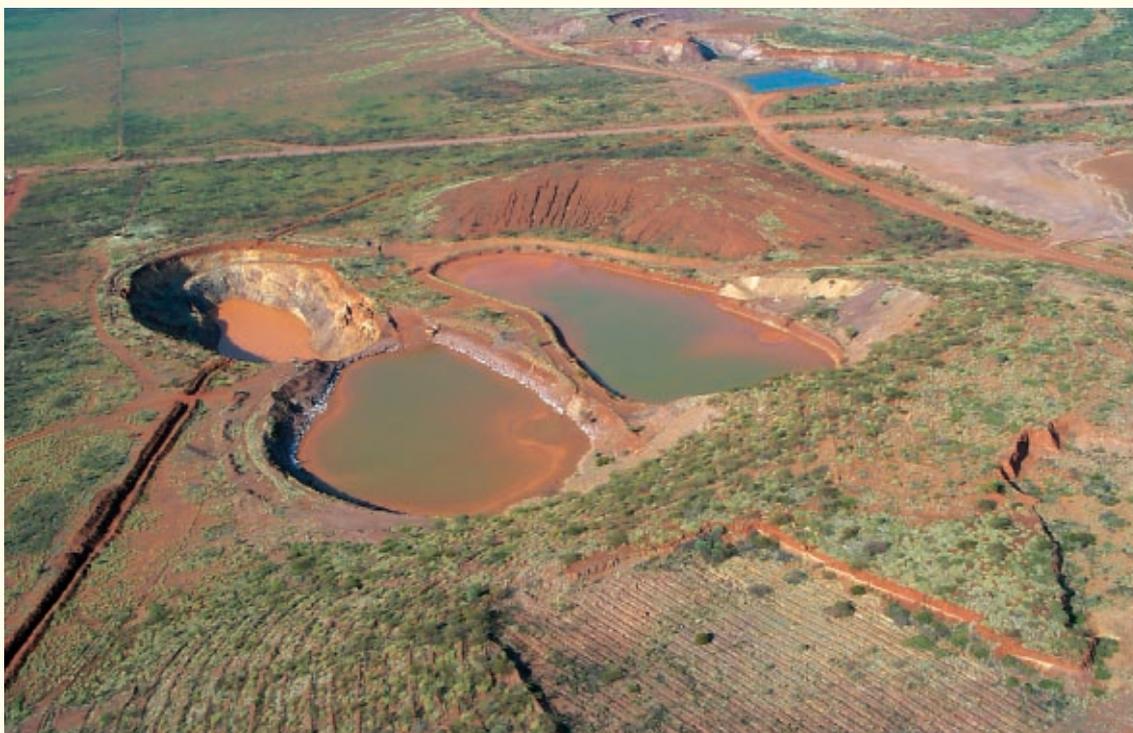
Newmont's Tanami Operation, Assault [right] and Battery [lower] Pits being backfilled with tailings. Bastille Pit [left] used for stormwater runoff.

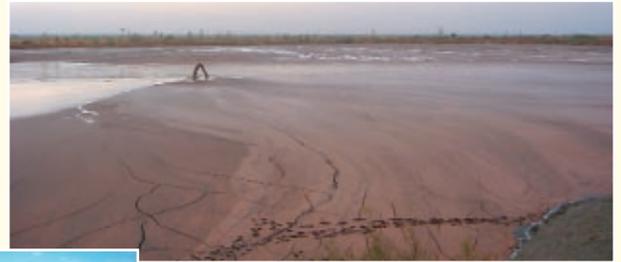
[Above] Bullakitchie Pit. Creating self-shedding profile by central discharge of thickened tailings.

To reduce costs an innovative technique was developed to minimise the amount of waste rock required by periodically topping up the pit with tailings to create the self shedding surface. Tailings were placed at a slow rate over the period 2000 to 2002. Placement of tailings compensated for the ongoing settlement and led to the formation of a strong trafficable crust.

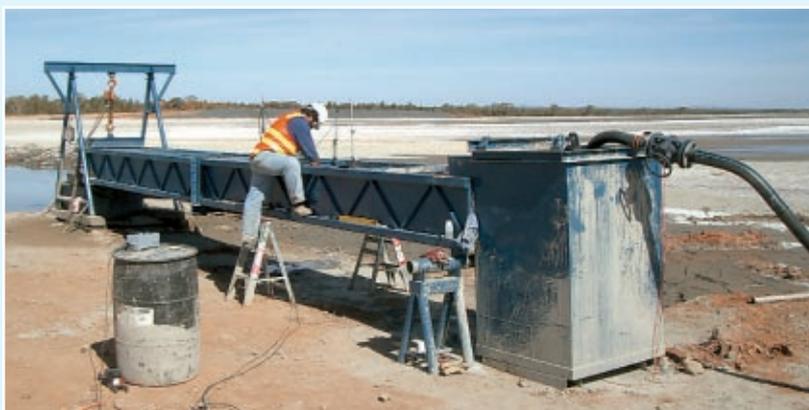
Testing in progress.

Research work on site to date has included flow-through flume testing with offtake from the tailings delivery line. This has enabled high flow rates of continuously fresh tailings to be used, an important distinction from what is normally available in a laboratory setting.

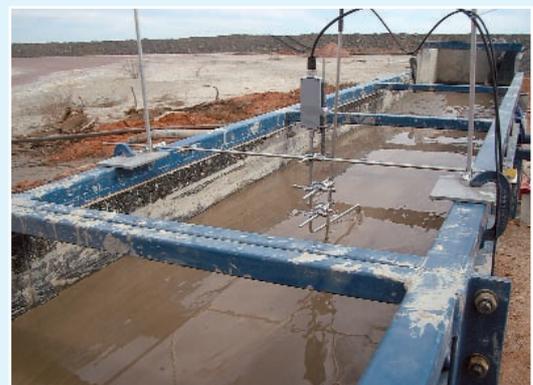
Electronic flow and density measuring equipment was supplied by Delft Hydraulics from the Netherlands.

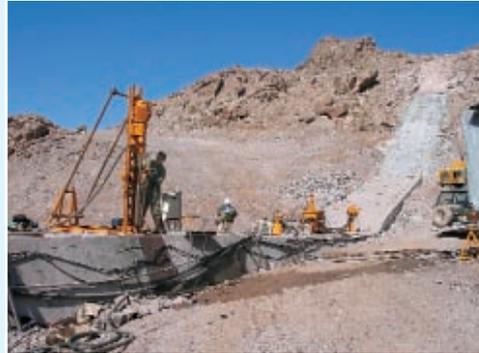
Grouting in progress at the water retaining dam.

Stage One of the tailings retaining dam is over 50% complete with more than 1,000,000 cubic metres of rockfill having been placed to date. At the water retaining dam the outlet pipe and plinth are complete and foundation grouting is in progress.

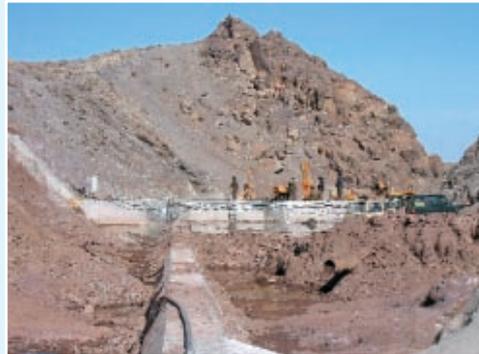
Grouting in progress at the water retaining dam. The outlet pipe (trapezoidal concrete structure) for return water is functioning as the stream diversion.

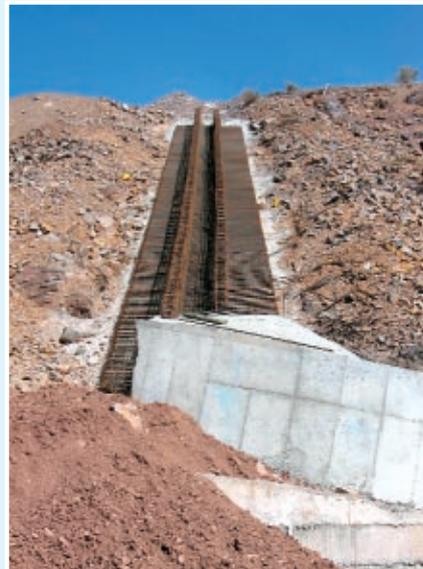
[Right] Decant structure under construction.

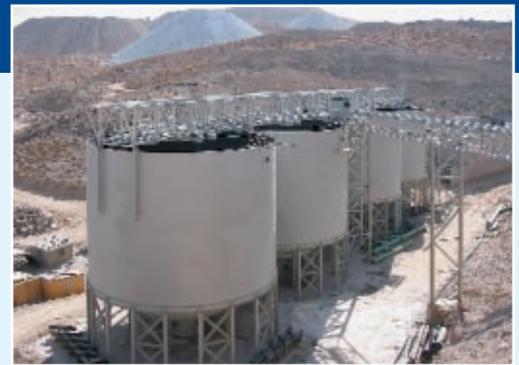
Deep Cone® Thickeners engineered by GL and V.

The Miduk Copper Project in Iran was featured in our Newsletters of June 2001 and April 2003. The tailings management system includes the construction of two dams and four Deep Cone® paste thickeners.

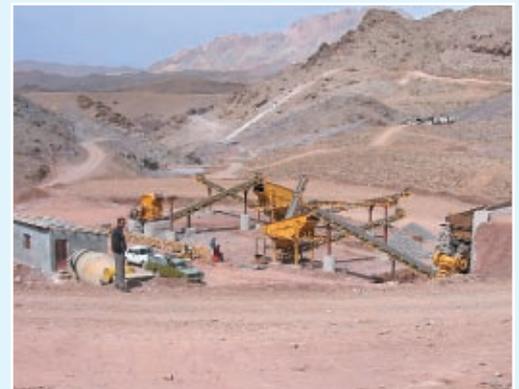
Mr. Abbar, site manager for SCICCo in front of the Crushing and screening plant. The plinth on the right abutment of the water retaining dam is visible in the background.

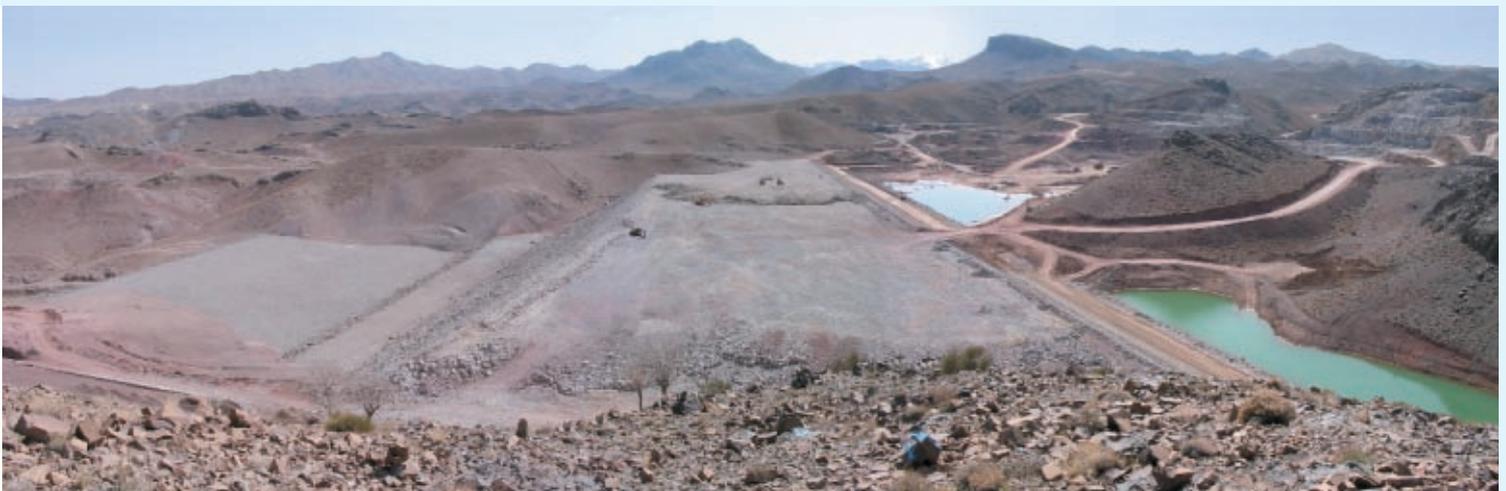
[Below] Stage One of the tailings retaining dam under construction. Rock quarries are on the right.
